Case Study 9

Little Blue River, Washington County, Kansas

Case Study 9	Little Blue River, Washington County, Kansas	Part 654 National Engineering Handbook	
	, , , , , , , , , , , , , , , , , , ,		
	Issued August 2007		
	Cover photo: Treated section Kansas	Cover photo: Treated section of the Little Blue River, Washington County, Kansas

By Philip G. Balch, Stream Restoration Specialist, and Brock Emmert, Stream Specialist, The Watershed Institute, Topeka, Kansas

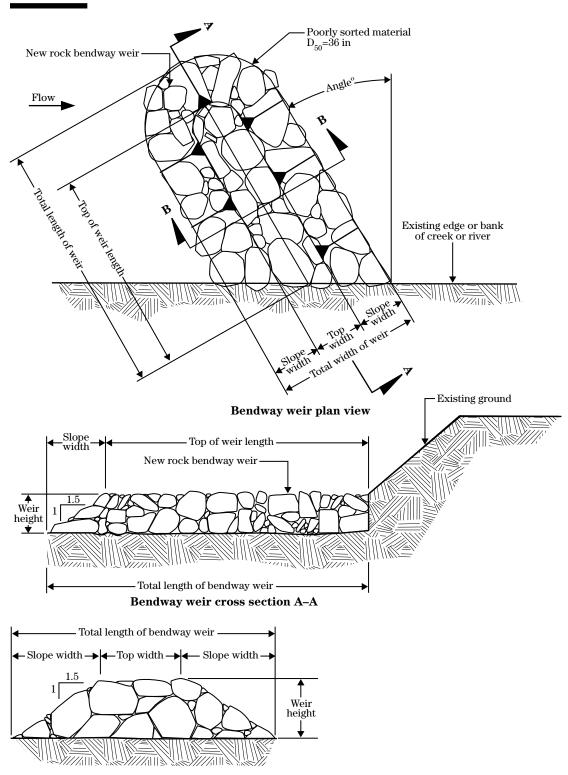
Figure CS9-4 Bendway weir detail

Bendway weir cross section B-B

shallow. The areas surveyed with water depths greater than 0.5 to 0.75 meter (18–25 in) were upstream of a few isolated, large, woody material piles. The SCC and KDHE staffs designed all projects, choosing bendway weirs for the primary stabilization structure because of the stream's high width/depth ratio (fig. CS9–4).

Bendway weirs redirect water flowing over them, which slows water velocities along the near bank region (Derrick 2001). A weir also moves the thalweg away from the bank to the end of the weir. The design height of all bendway weirs was a third to a half meter (1–1.5 ft) above the water surface at low flow. David Derrick, USACE, reviewed the initial 20 project designs.

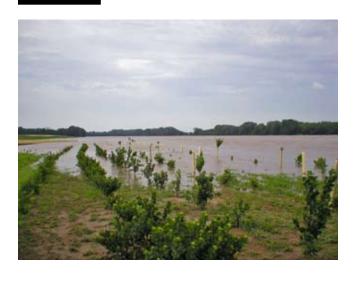
Figure CS9–14 Site 1, June 24, 2003, prior to peak flood

Projects completed in early 2002 were inundated with two flows that approached the bankfull magnitude in June and September 2002. Another bankfull flow event occurred in early May 2003. Minimal erosion occurred at the stabilized sites during these flows. Slight erosion from the moderate flows required the addition of one structure on two sites. In late June 2003, severe weather and torrential rainfall in south-central Nebraska resulted in substantial flooding along the Little Blue River (fig. CS9–14).

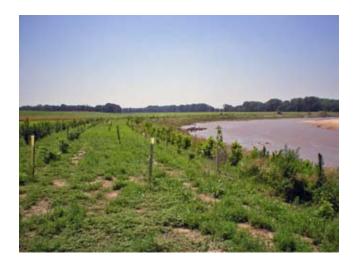
Figure CS9–15 Site 1, July 2, 2003, following 1,133 cubic meter (40,000 ft³/s) flow

second (40,000 ft³/s) at the Hollenberg, Kansas, stream gage. Downstream, at the USGS gage near Barnes, Kansas, flows peaked at 906.3 cubic meters per second (32,000 ft³/s). No damage occurred at 20 of the 24 completed sites (fig. CS9–15). Four sites did incur slight damage that was limited to a small portion of each. The problems all appeared on the lower third of the
